PHOENIX INK

June 2003

LOOK CLOSELY, IT MAY NOT BE WHAT YOU THINK

By Donald F. Peak, C.F.I.

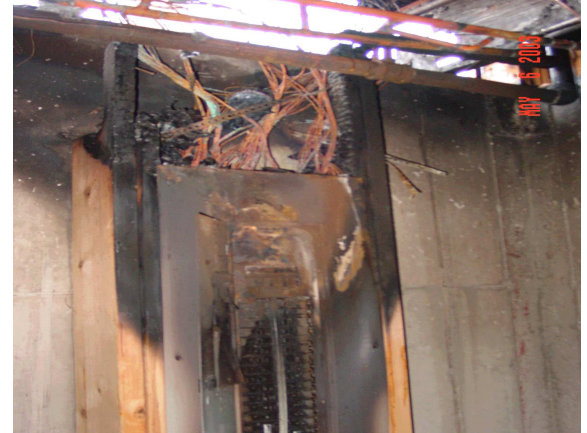
Case Study #1: An extensive fire occurred in a new home and the initial investigation placed the fire's origin in the electrical breaker panel. The initial investigation found fire burned a “V” pattern starting at the center of the breaker panel on the basement wall and extended up into the basement ceiling causing extensive damage to the main level floor and in-floor radiant heat system. The subsequent investigation found a gas leak occurred on the exterior of the home and penetrated the basement foundation wall through the electrical panel service entry. The fugitive gas was ignited by a pump pressure switch, burned up behind the breaker panel causing the “V” pattern, and caused fire damage that appeared to originate in the electrical breaker panel. These findings changed the potential liable parties and required several reexaminations of the scene.

Breaker panel mounted on basement wall

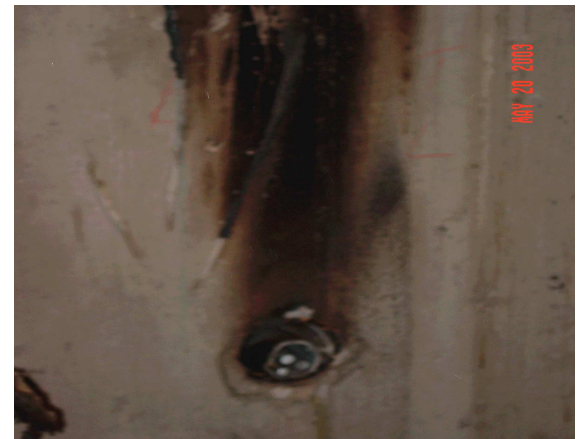
Breaker panel removed showing gas entry and burning through main electrical service feed
